AHERA/NESHAP ASBESTOS INSPECTION REPORT
1126 CASTLE STREET
ROCK HILL, SC

SUMMIT Job No. 1080.115

AHERA/NESHAP ASBESTOS INSPECTION REPORT

1126 CASTLE STREET, ROCK HILL, SC 29732

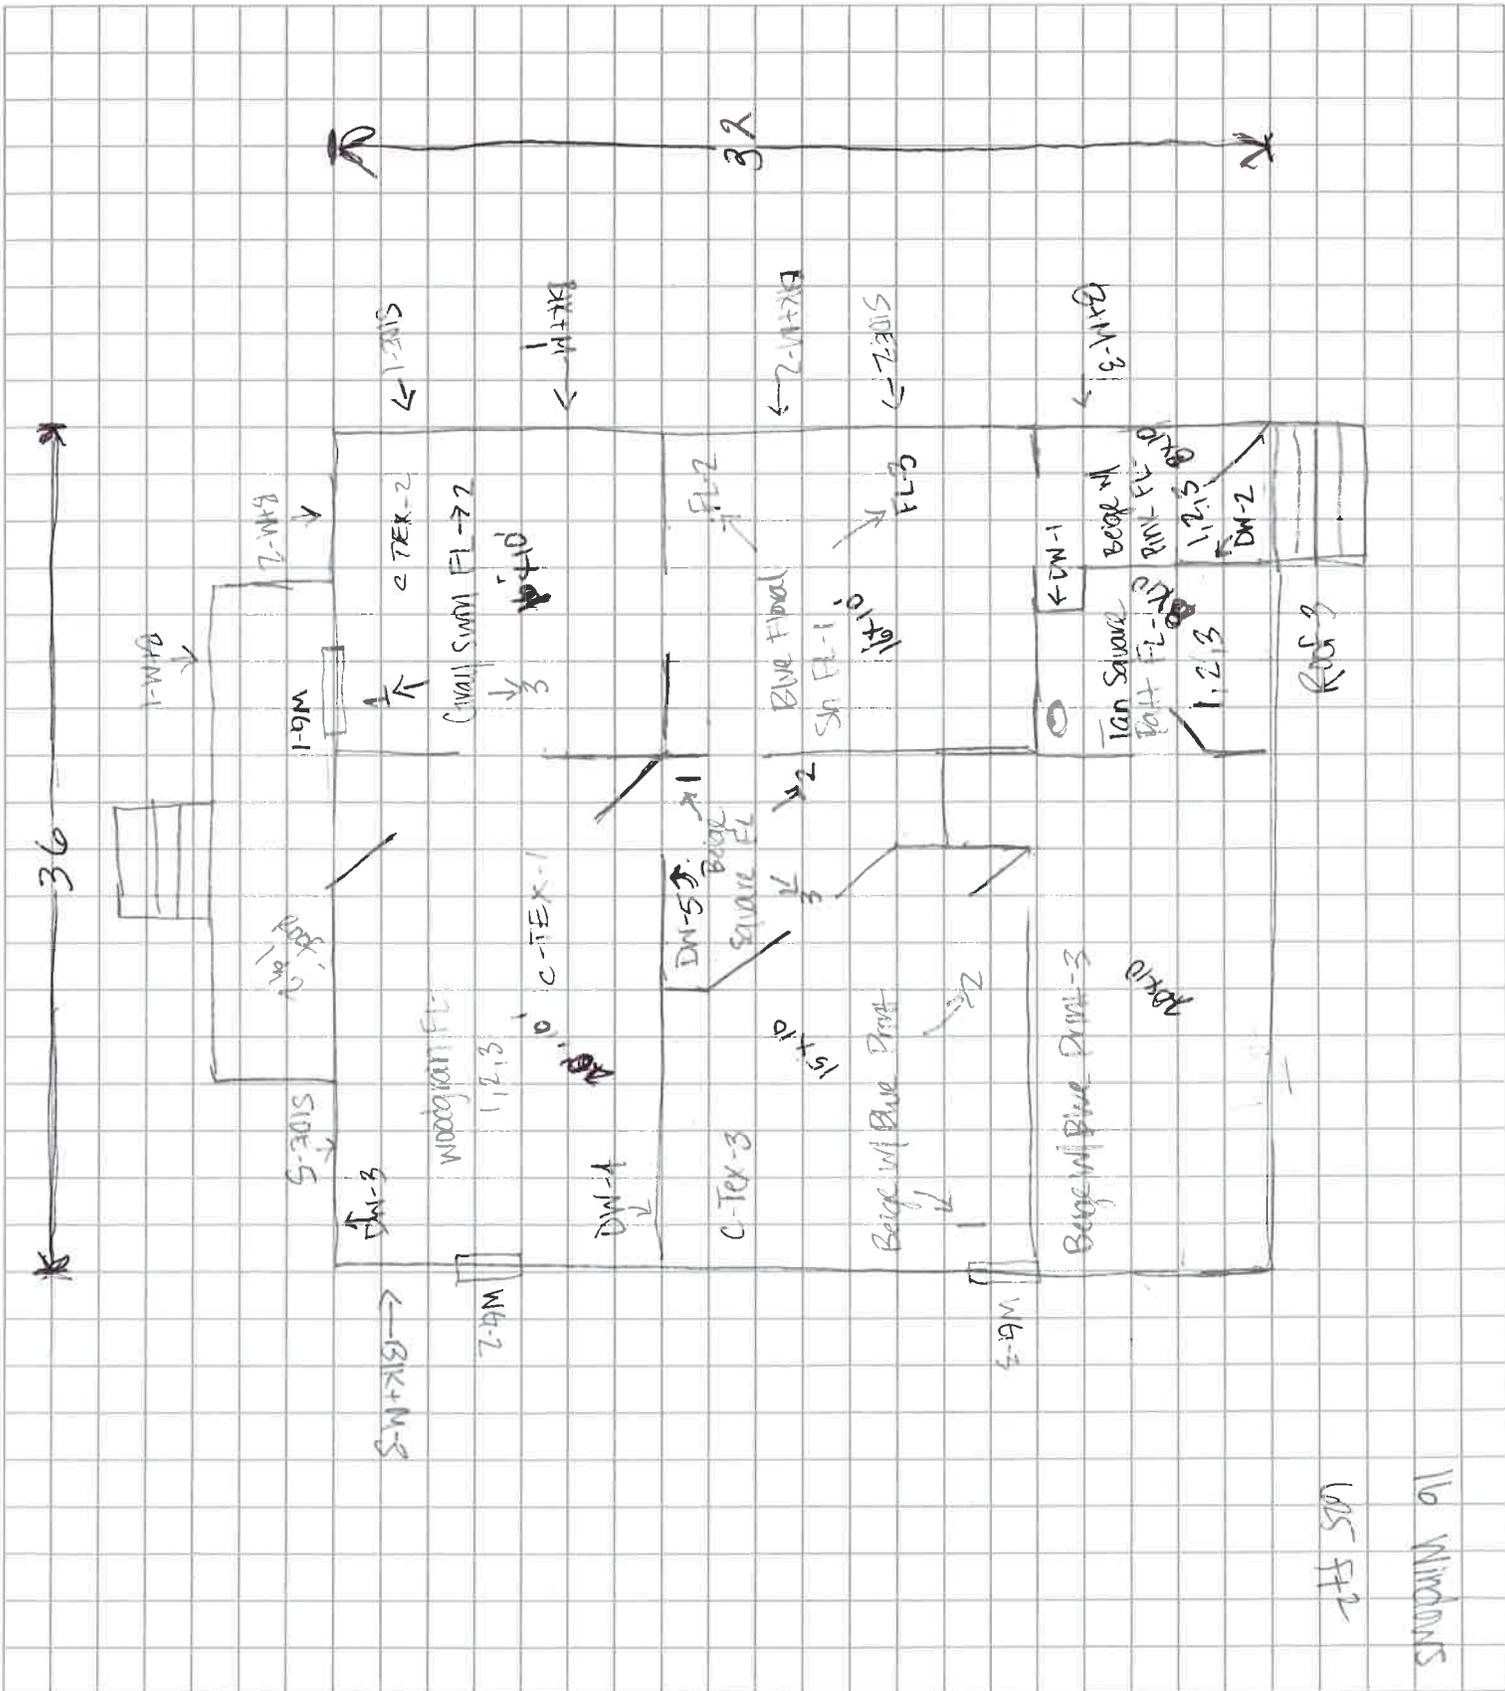
SUMMIT DOCUMENTATION

approximately 400 sq. ft. of the material. The sample analysis is enclosed in Appendix A. A detailed map showing the sampling locations can be found in SUMMIT Documentation.

The woodgrain sheet flooring and mastic located in the living room is currently in damaged condition and non-friable with a potential for disturbance. The material is classified as miscellaneous material. The flooring and mastic was sampled and is not classified as Asbestos Containing Material (ACM). The sample analysis is enclosed in Appendix A. A detailed map showing the sampling locations can be found in SUMMIT Documentation.

The gray swirl flooring and mastic (multiple layers) located in the dining room and living room is currently in damaged condition and non-friable with a potential for disturbance. The material is classified as miscellaneous material. The flooring and mastic was sampled and is not classified as Asbestos Containing Material (ACM). The sample analysis is enclosed in Appendix A. A detailed map showing the sampling locations can be found in SUMMIT Documentation.

The blue floral flooring and mastic (multiple layers) located in the kitchen is currently in damaged condition and non-friable with a potential for disturbance. The material is classified as miscellaneous material. The flooring and mastic was sampled and is not classified as Asbestos Containing Material (ACM). The sample analysis is enclosed in Appendix A. A detailed map showing the sampling locations can be found in SUMMIT Documentation.

The beige with pink flooring and mastic located in the entryway is currently in damaged condition and non-friable with a potential for disturbance. The material is classified as miscellaneous material. The flooring and mastic was sampled and is not classified as Asbestos Containing Material (ACM). The sample analysis is enclosed in Appendix A. A detailed map showing the sampling locations can be found in SUMMIT Documentation.

The beige square patterned flooring and mastic (multiple layers) located in the hallway is currently in damaged condition and non-friable with a potential for disturbance. The material is classified as miscellaneous material. The flooring and mastic was sampled and under layer of beige and pink flooring is classified as Asbestos Containing Material (ACM). The under layer of beige and pink flooring material contains up to 8% Chrysotile and there is approximately 400 sq. ft. of the material. The sample analysis is enclosed in Appendix A. A detailed map showing the sampling locations can be found in SUMMIT Documentation.
